Notice Sheet 13

Ford Ranger/
Mazda BT50
Clutch Damper

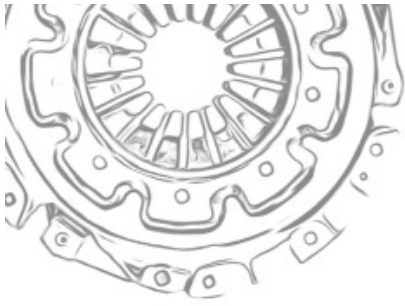
The hydraulic clutch damper located on the firewall (circled in the image below) can perish over time and close inspection of the damper is required at the time of clutch fitment.

Failure to identify or replace faulty clutch damper may result in loss of pedal pressure and/or difficult gear selection.
